# Fly-by-night fabricators undermine stainless steel promise

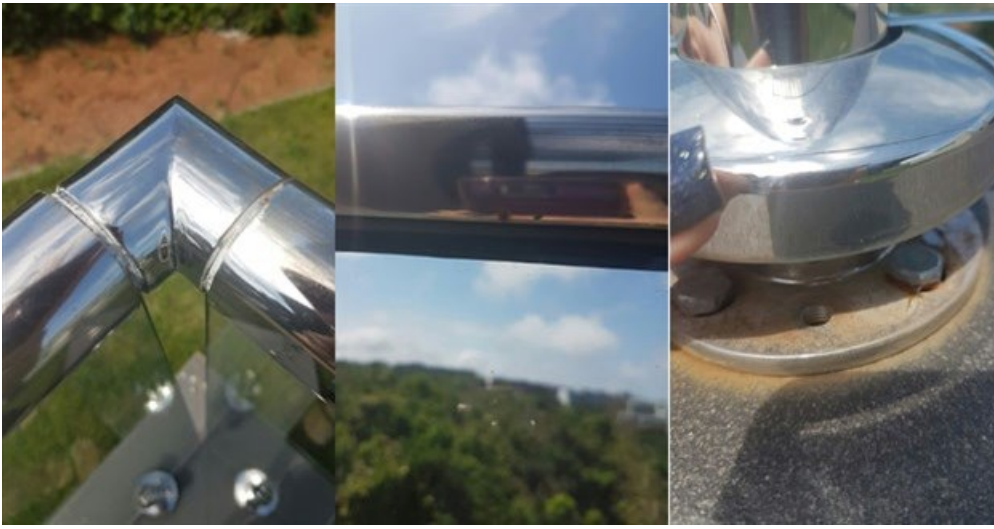
“It was completely unacceptable that carbon steel bolts had been used which accelerate galvanic corrosion and would cause the balustrade to fail in a relatively short period, leading to a possible safety hazard. The balustrade materials had also been contaminated by carbon steel carry-over in places, either during fabrication or installation, resulting in premature staining of the base material. Joints in the balustrade had been glued with an epoxy or adhesive instead of being welded and had come loose, with further poor joint quality seen in its construction, and the stainless steel had not been correctly polished after installation.”

Example of sub-standard stainless steel balustrade installation in KwaZulu-Natal.

“The job clearly did not comply with the legal requirements of SANS 10400 or SANS 10160, both of which require approval of the design and installation by a suitably qualified professional engineer, which we doubt was done. Quite bluntly, the balustrade was a hazard and dangerous to the safety of the home owner. We advised that the entire structure should be removed at the fabricator’s cost, and replaced using an experienced balustrade manufacturer,” says Baker.
