Streamlining the installation of a complex residential roof - a case study

Stian de Jager, Institute for Timber Construction South Africa (ITC-SA) Category A Roof Inspector, weighs in on installation difficulties with complex residential roofs by drawing lessons from a completed roofing project in Kensington, Johannesburg, in which he was involved.

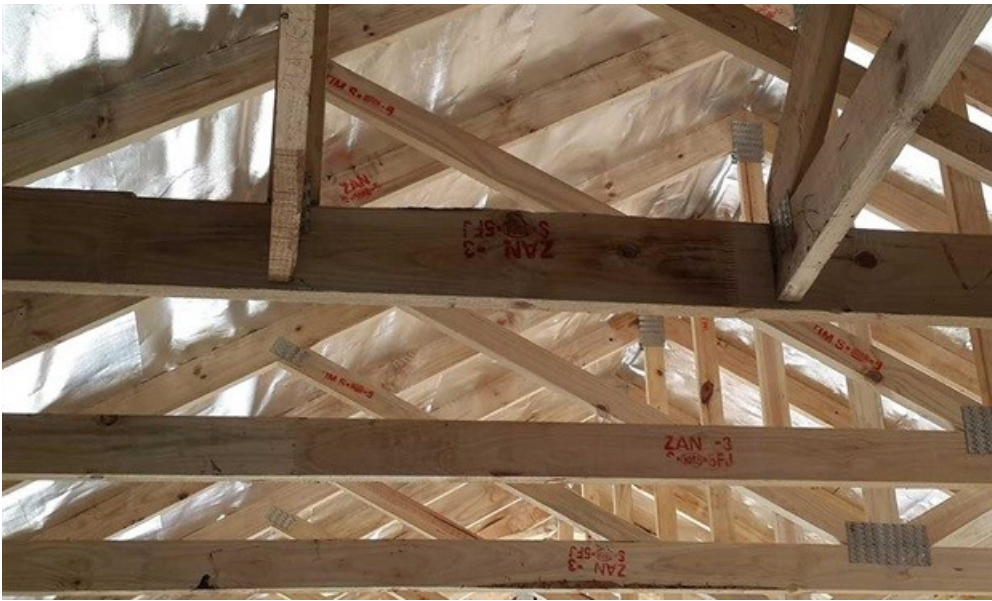
Truss hangers not installed due to a mix-up with a different section and detail.

“When a collaborative approach is not possible from the start of the project, it can be of great benefit to all parties to get a competent roof inspector involved from the start of the roof installation,” advises de Jager. “Depending on the complexity and scale of the project, the roof inspector would visit the site at least daily to ensure that mistakes are not compounded and that the communication between installer and designer is clear. The inspector or engineer responsible for signing off the roof should also be able to observe and request any required special details in a timely manner. These simple steps can greatly reduce the time spent on site and ensure an accurate and efficient installation process,” he concludes.

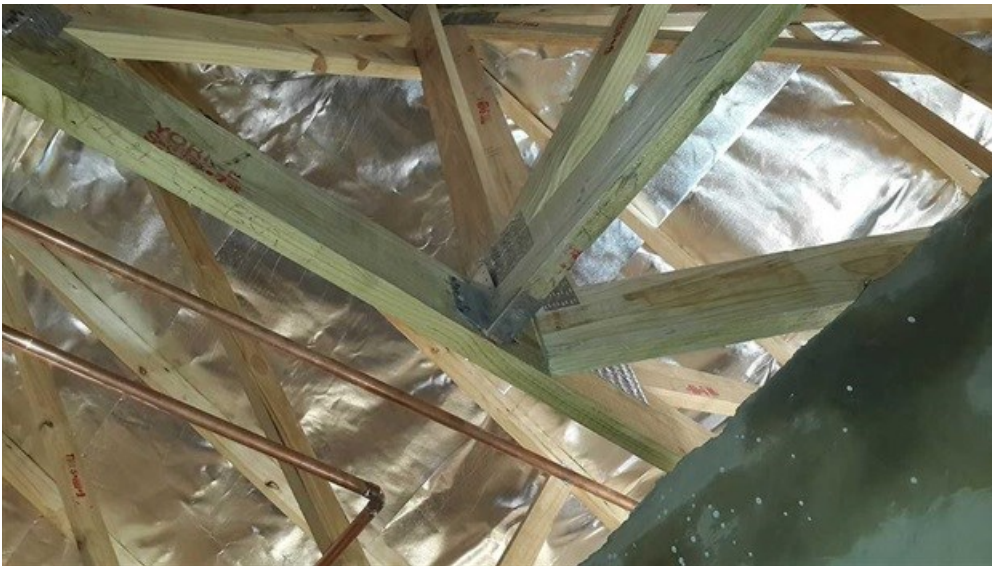
Inadequate or incorrect nailing of truss hangers, bracing, truss and batten connections is another common error. De Jager notes, “Because of the overwhelming complexity, confusion of bracing items, cleats, hanger and other details can occur, with many being switched around and some even being left out completely. In the same way, several of the small trusses can be neglected, because the main trusses are repeatedly repositioned in an attempt to ‘make the roof fit’. These are then left out of the structure, causing some unstructured open spaces in the roof, which then leaves the adjacent trusses to carry an additional load that they were not designed to bear.”

A 45-degree truss hanger not installed and a 90-degree hanger not completely nailed.
